Premier Home Inspection Report

Sample – Premier Home Inspection

Prepared By:
Structure & Site
Inspection Services LLC

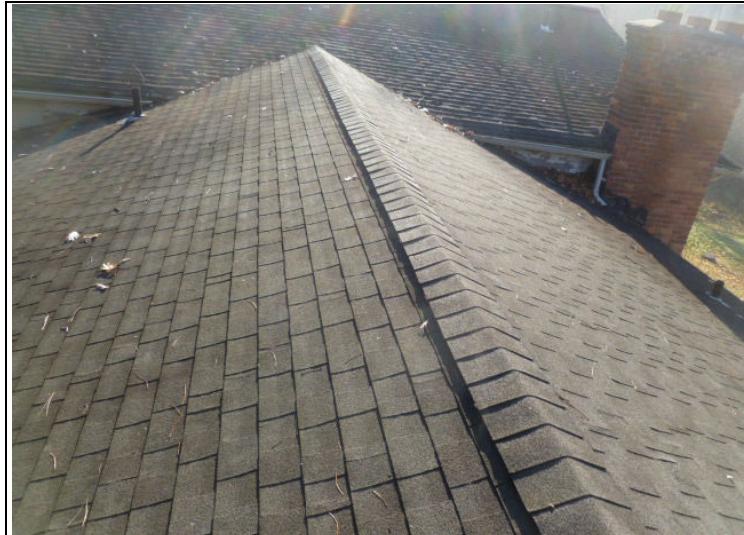
- **Monitor:** The roofing is in fair condition. We did not see evidence of active leaks or need for immediate major repair.
- **Improve:** Organic growth on roof surfaces should be treated to prevent decay of roof material. Recommend contacting www.roofmedic.com, a local company that applies an EPA registered chemical to the roof that removes the moss and other organic material for the surface material.

Moss build up on the roof usually results from excessive shade or ponding of water and can lead to shortened roof life and increased risk of leaks.

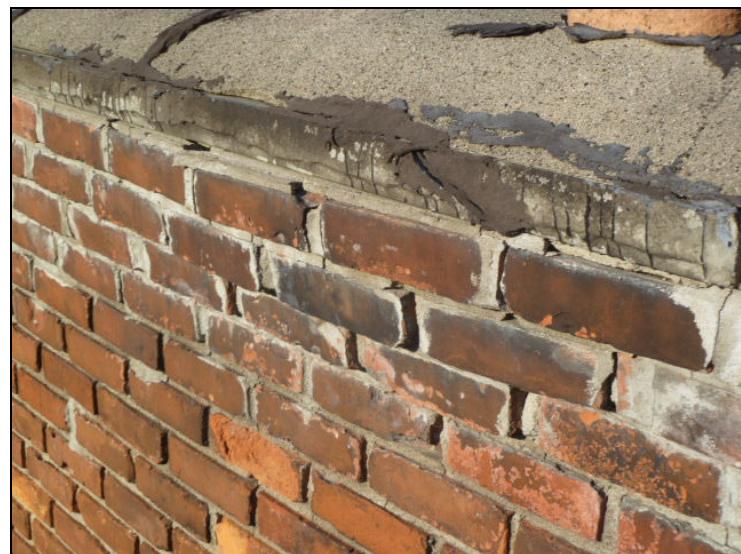
Monitor: The masonry chimneys shows evidence of spalling (surface deterioration of the masonry). Rebuilding of this chimney will ultimately be necessary.

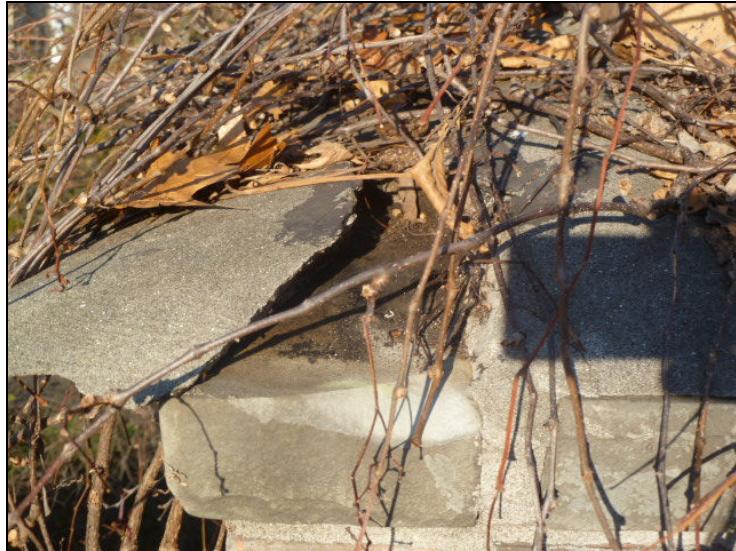
Cap damage on side chimney.

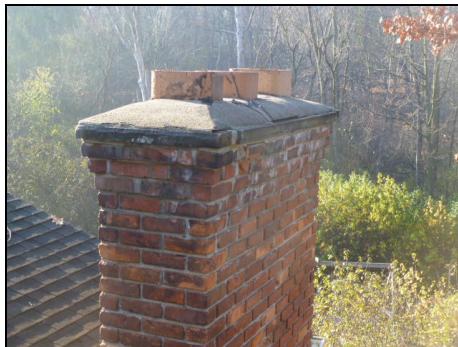
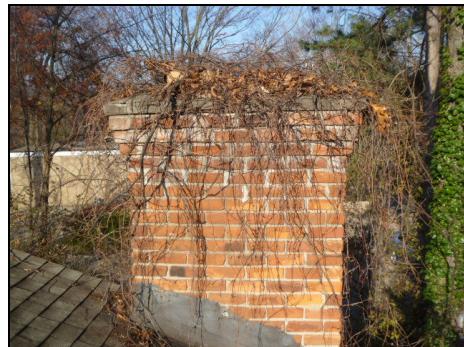
- **Monitor: Deferred Cost:** The center masonry chimney does not have saddle flashing at the roof slope. This condition can cause water entry where the flashing meets the brick work. It is recommended that a saddle flash be installed during the next roof replacement.
- **Repair:** A rain cap and vermin screen should be installed on the masonry chimneys and the chimney flue should be checked for damage. Damaged flues can be unsafe.

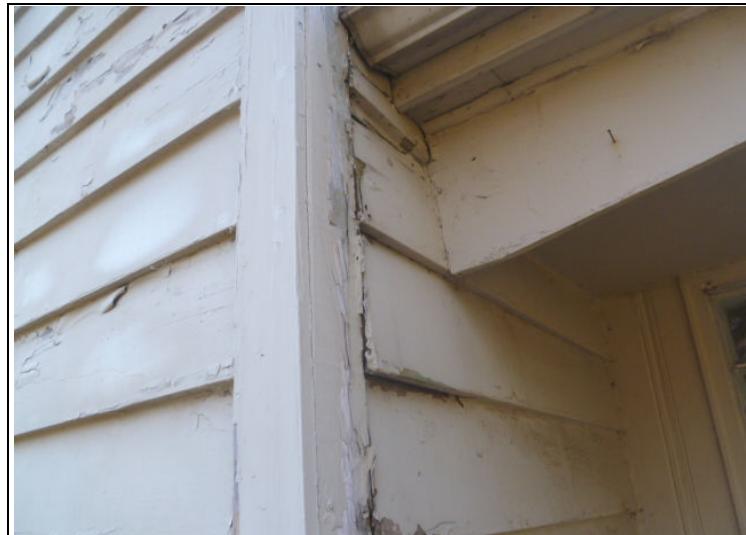
View of water damaged exterior wall materials.

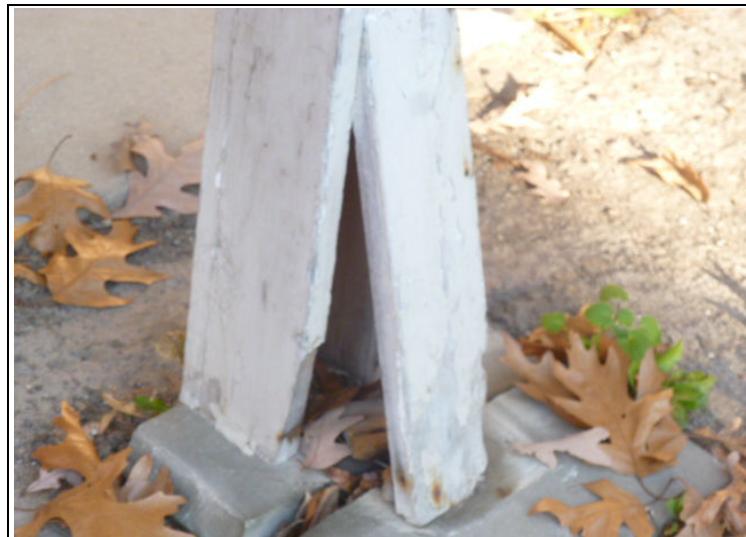
- **Repair:** The bottoms of the support posts for the carport are rotted. They should be repaired to avoid movement in the structure.

View of damaged support posts serving carport structure.

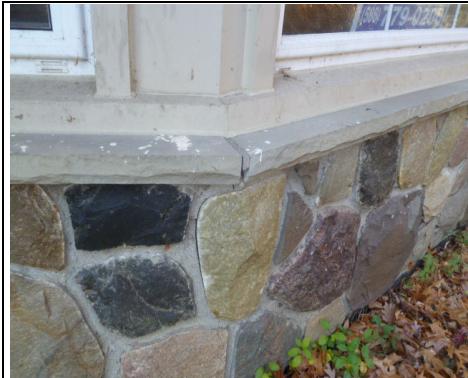
View of loose mortar at stone siding.

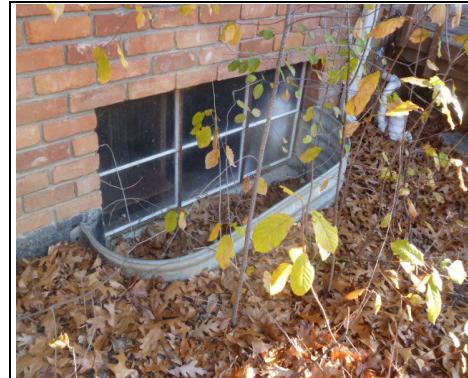
Window wells need covers.

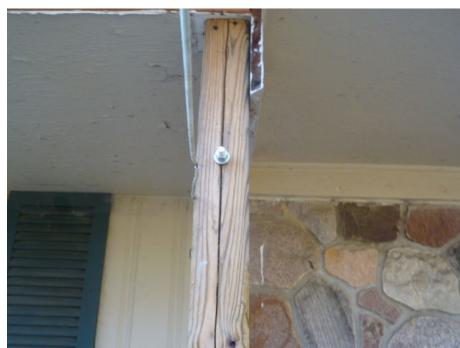
Split support post at front entrance.

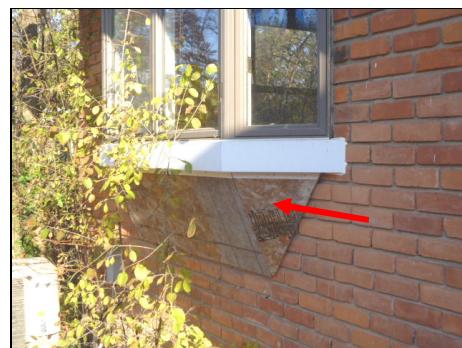
Exposed wood at rear bay window.

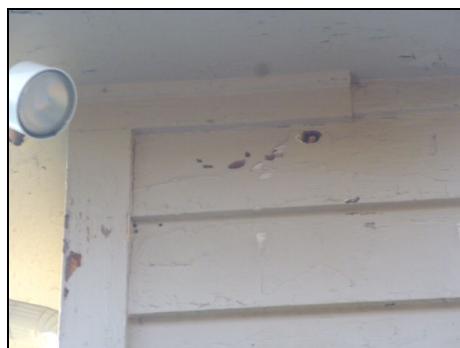
Evidence of wood boring insect damage.

- **Repair:** Evidence of wood boring insect damage was observed at exterior materials and there is risk of additional hidden damage. If the property has not already been treated, a licensed pest control specialist should be engaged to treat the property. Damaged wood should be repaired or replaced. Recommend having property inspected and treated by a professional extermination company.
- **Monitor:** Conditions that are attractive to wood boring insects should be avoided since they can damage the property. These conditions include overhanging tree limbs, vegetation at exterior materials, wood/soil contact around the perimeter of the home (decking, siding, etc.), damp soils, leaky roofs, and unventilated spaces (roofs, garages, crawl spaces, etc.).

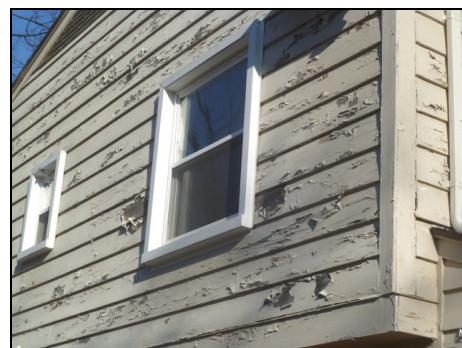
Wood siding needs painting.

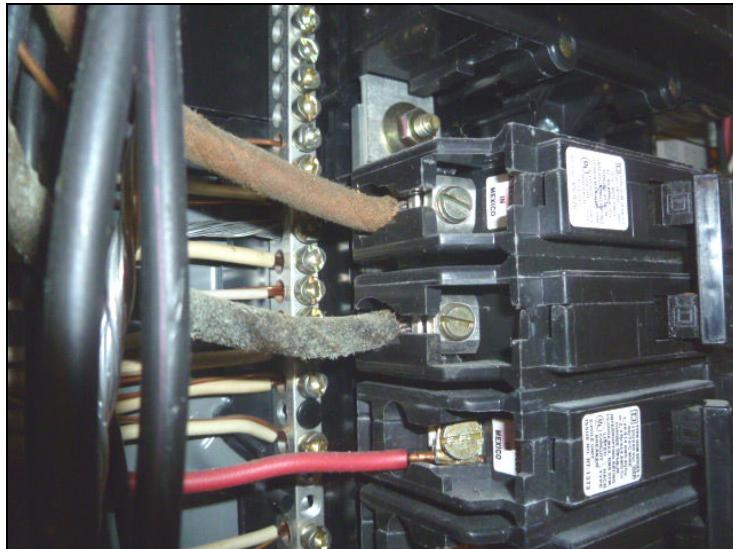
Fabric jackets in main panel need to be trimmed.

- Repair:** Fabric jacket electrical connections within the main distribution panel should be trimmed back from the contact points to reduce the risk of the jacket catching fire if a spark occurs at the circuit.

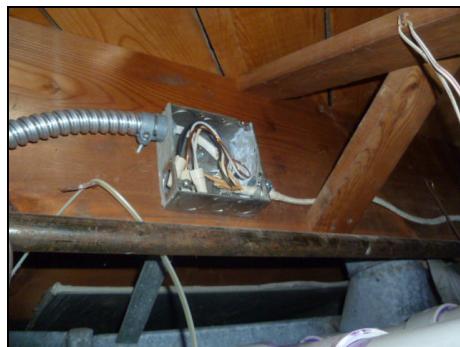
Open junction boxes need to be covered.

- Repair:** Abandoned wiring at exterior should be replaced or appropriately terminated.
- Repair:** All junction boxes should be fitted with cover plates, in order to protect the wire connections.

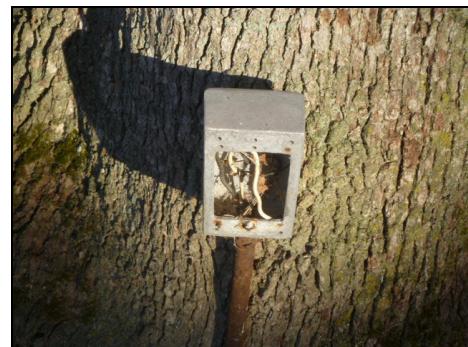
- Repair:** An outlet in the front yard is damaged. It should be replaced.

Damaged and exposed wiring at front yard.

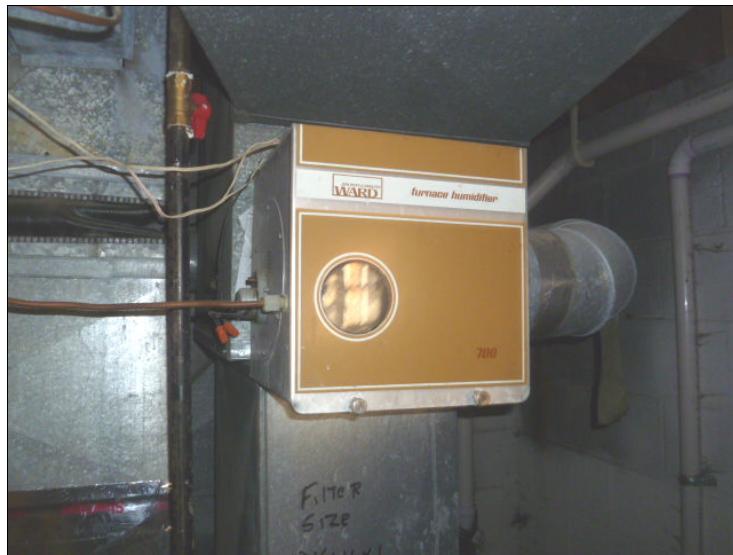
Recommend replacing humidifier.

- **Repair:** The humidifier should be replaced. Watch out for humidifier leaks into the furnace where costly (and hidden) damage can occur.
- **Improve:** The dirty air filter should be replaced.

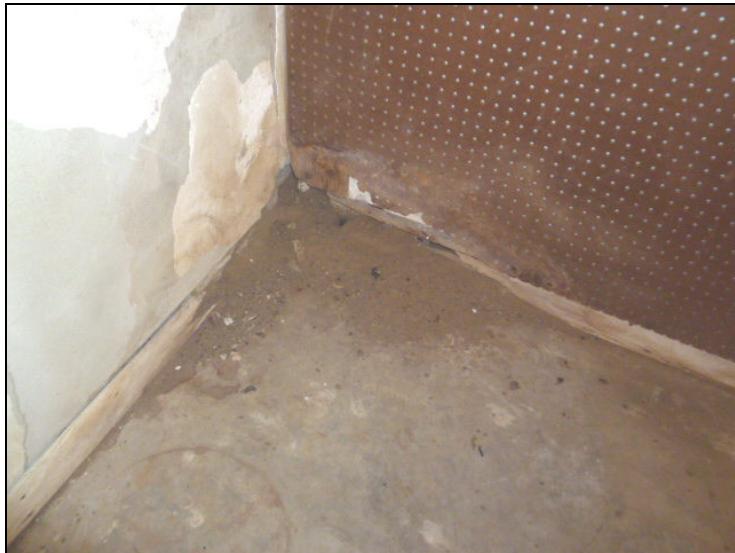
Active leak into garage from exterior wall.

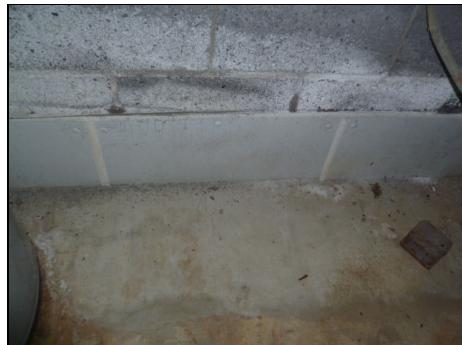
- **Monitor:** The basement shows evidence of moisture penetration. *It should be understood that it is impossible to predict the severity or frequency of moisture penetration on a one-time visit to a home.* Virtually all basements exhibit signs of moisture penetration and virtually all basements will indeed leak at some point in time. The visible evidence is not unusual for a home of this age, construction and location. Further monitoring of the foundation will be required to determine what improvements, if any, will be required. Basement leakage rarely affects the structural integrity of a home. The vast majority of basement leakage problems are the result of insufficient control of storm water at the surface. The ground around the house should be sloped to encourage water to flow away from the foundations. Gutters and downspouts should act to collect roof water and drain the water at least five (5) feet from the foundation or into a functional storm sewer. Downspouts that are clogged or broken below grade level, or that discharge too close to the foundation are the most common source of basement leakage. Please refer to the Roofing and Exterior sections of the report for more information.

Efflorescence observed at areas of block.

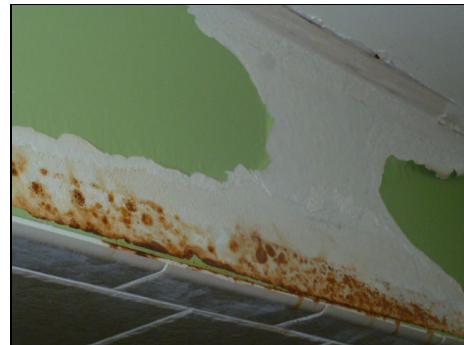
- **Monitor:** Water staining was noted in various locations.

Water staining in bathroom.

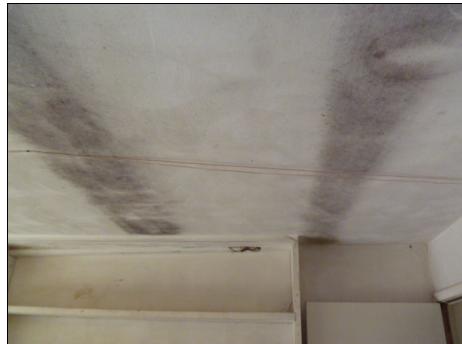
Mold growth in garage.

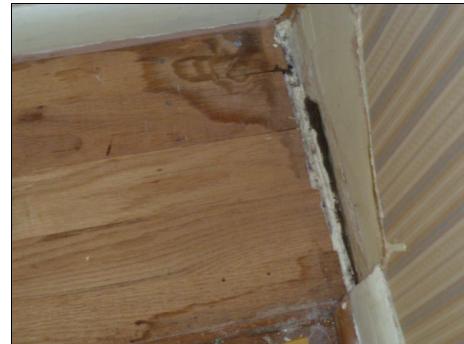
Water staining on floor from exterior leak.

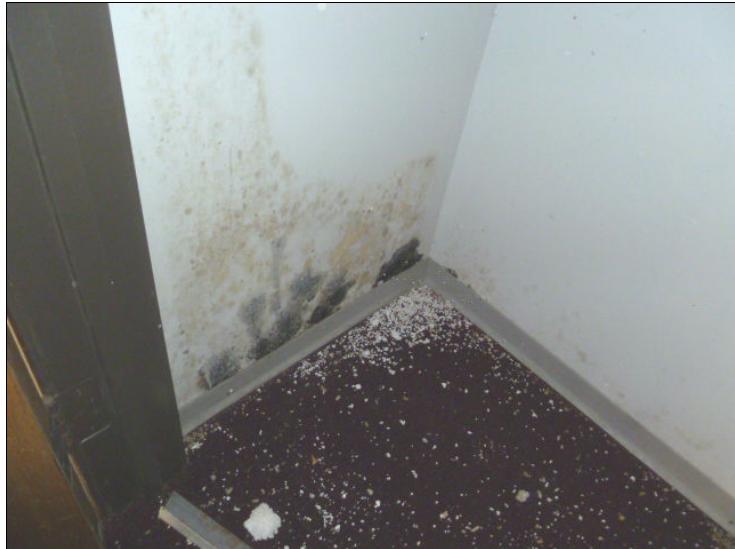
- **Repair:** Extensive mold growth was observed in the basement drywall and garage drywall. Mold growth is a reaction to sustained moisture infiltration and the condition should be further evaluated. Mold growth within an enclosed environment can be detrimental to the inhabitant's health. Typically, removal of all contaminated materials and eliminating the moisture infiltration are the steps necessary to correct the situation. Visit www.epa.gov/mold for more information. Recommend removal of contaminated materials and associated abatement procedures.

Mold growth within basement drywall.
