Home Inspection Report

Sample - Standard Home Inspection

Prepared By: Structure & Site Inspection Services LLC

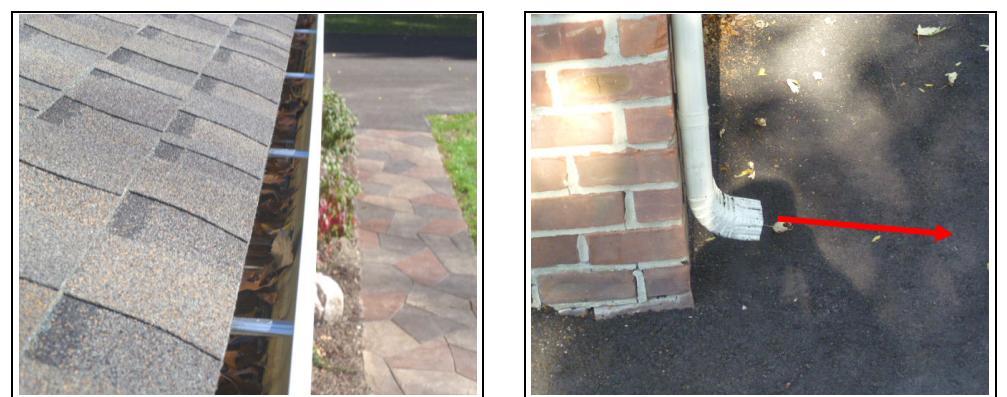
Roof drainage configuration. Note gutters full of debris. Extend downspouts away from foundation.

• **Repair:** The downspout(s) should discharge water at least five (5) feet from the house. Storm water should be encouraged to flow away from the building at the point of discharge.

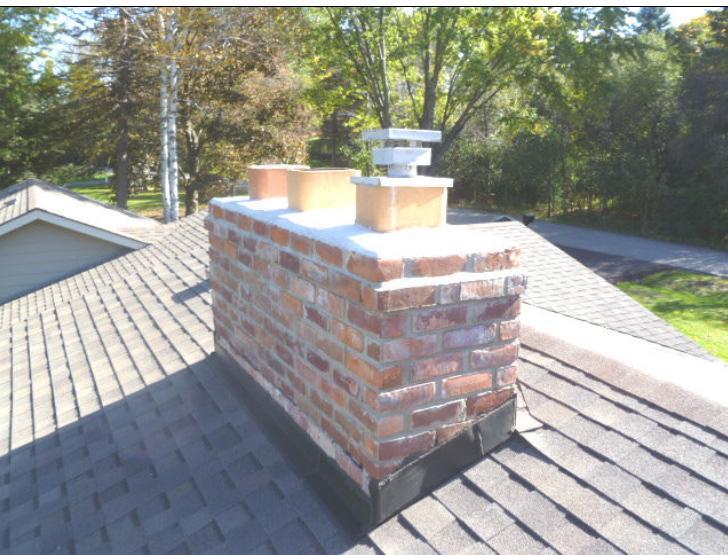
Chimney in good condition. Recommend capping middle flue.

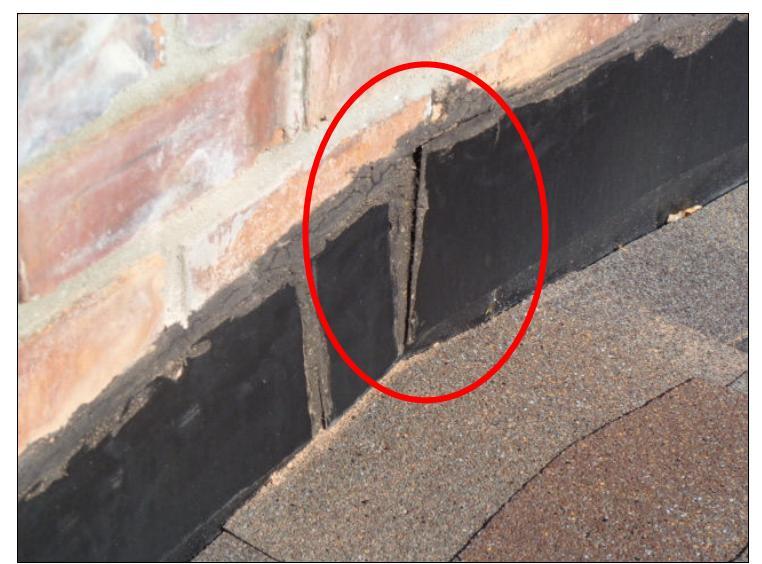
Repair: The flashing is loose at the chimney and should be re-secured to avoid leaks.

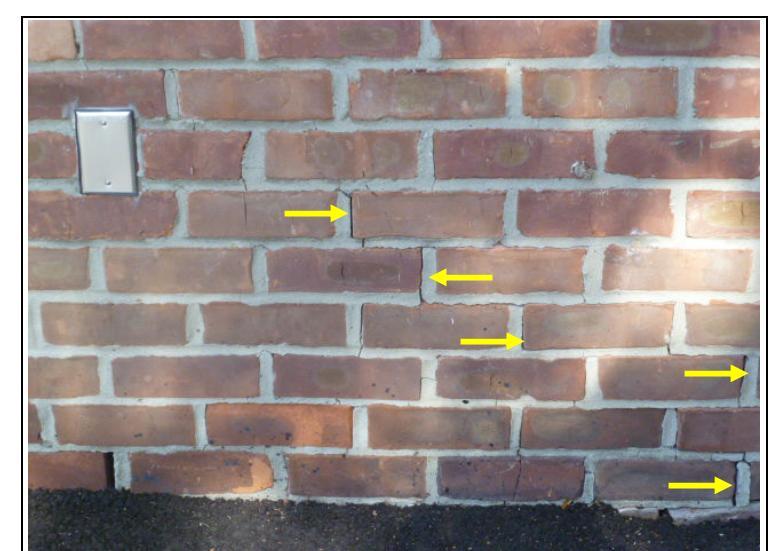
View of step cracking at front wall.

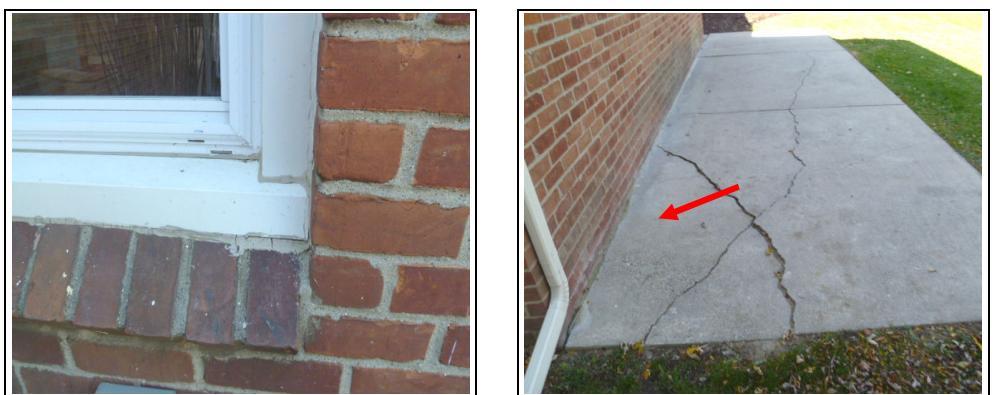
• **Possible Major Concern, Monitor:** The rear concrete slab slopes towards the house. This condition can cause water entry in the building. It is difficult to improve this situation without re-grading the concrete adjacent to the foundation.

View of window frames. View of cracking concrete slab at rear of garage. Slab slopes towards foundation.

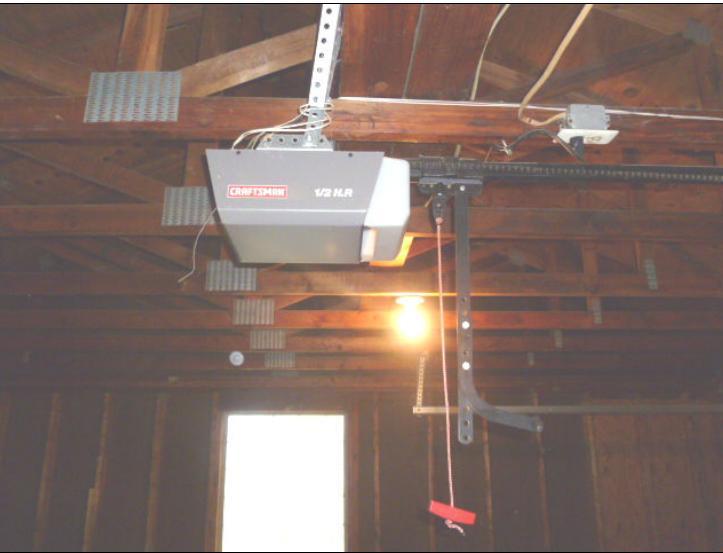
• Repair: The garage door opener is inoperative. It should be repaired as necessary.

Garage door opener not attached to door.

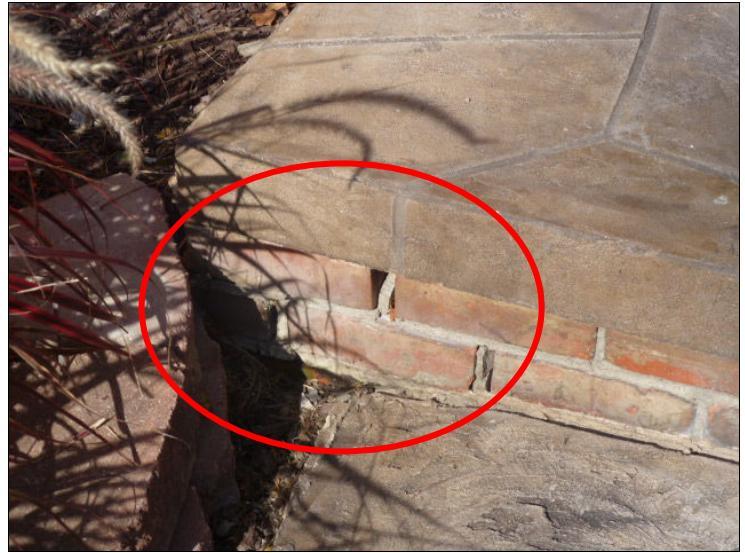
• **Repair:** The porch masonry is deteriorating noticeably. Repairs or rebuilding may eventually be needed here and may involve significant expense.

Loose brick and mortar at front porch base.

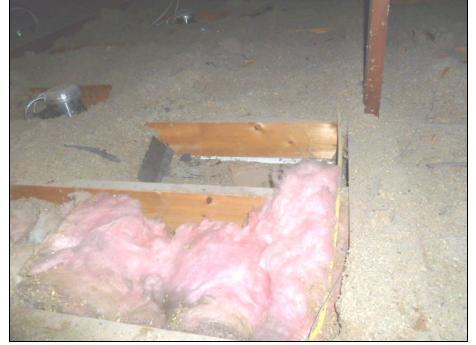
Low insulation levels should be improved.

• **Repair:** Insulation should be increased and evened out.

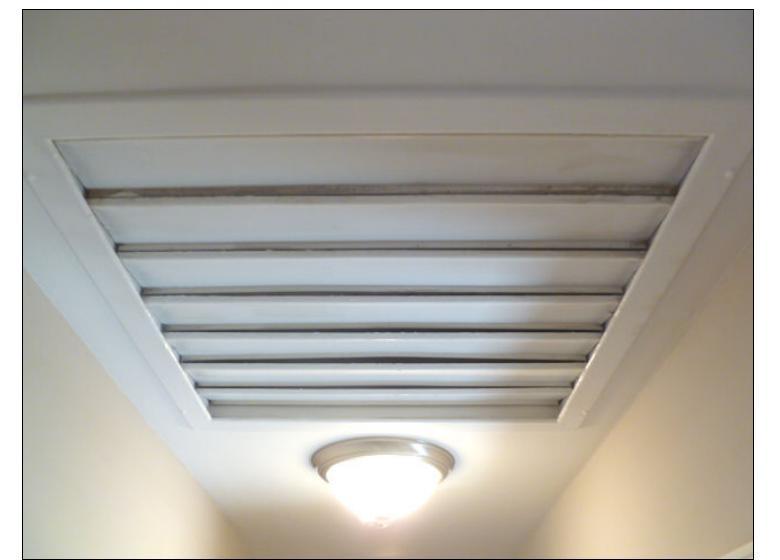
Gaps in attic fan grill should be reduced or eliminated to prevent heat loss into attic.

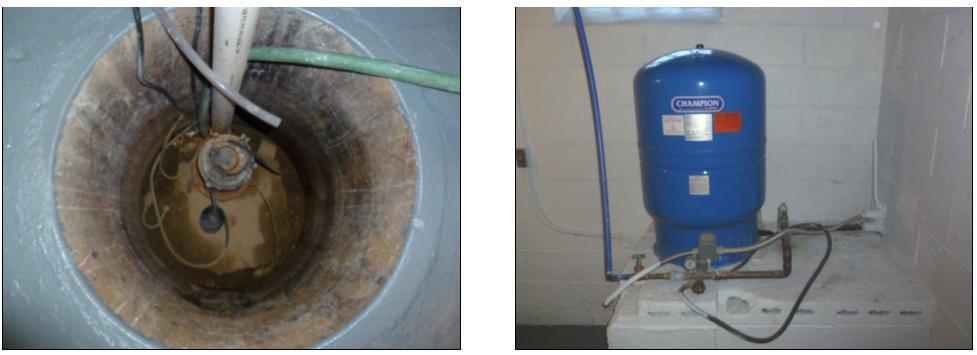
Dry sump – needs cover to reduce radon gas entry. Well tank supplies adequate pressure.

• Monitor: Dry sump. Recommend filling sump to test pump and discharge line.

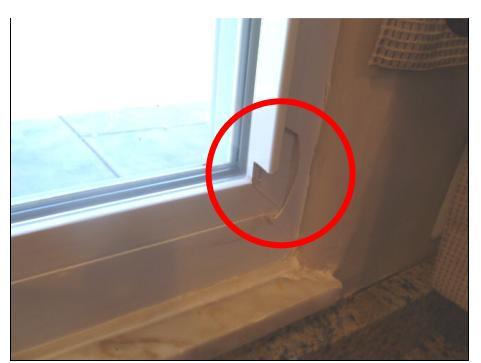
Cracked frame in kitchen.

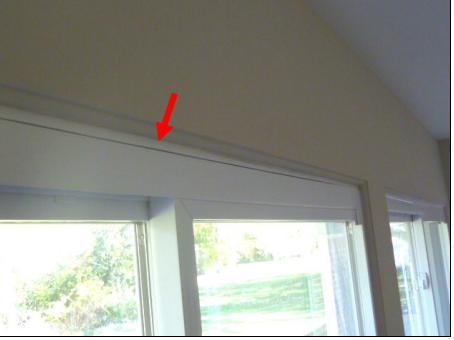
Gap in living room window frame.

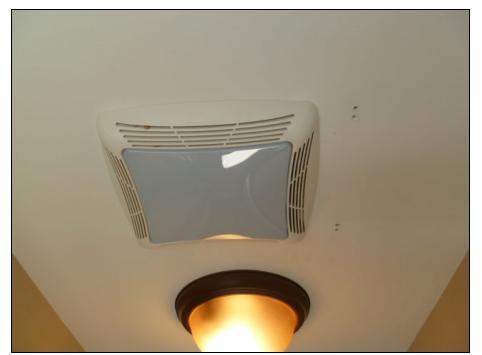
• **Repair:** The hallway bathroom exhaust fan inoperative – no electrical connection to fan.

Hallway bathroom vent inoperative.

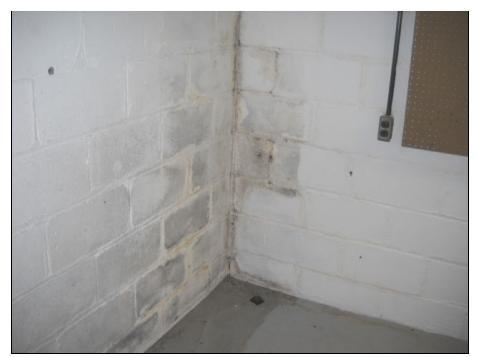
• Monitor: The basement shows evidence of moisture penetration. *It should be understood that it is impossible to predict the severity or frequency of moisture penetration on a one-time visit to a home*. Virtually all basements exhibit signs of moisture penetration and virtually all basements will indeed leak at some point in time. The visible evidence is not unusual for a home of this age, construction and location. Further monitoring of the foundation will be required to determine what improvements, if any, will be required. Basement leakage rarely affects the structural integrity of a home. The vast majority of basement leakage problems are the result of insufficient control of storm water at the surface. The ground around the house should be sloped to encourage water to flow away from the foundations. Gutters and downspouts should act to collect roof water and drain the water at least five (5) feet from the foundation or into a functional storm sewer. Downspouts that are clogged or broken below grade level, or that discharge too close to the foundation are the most common source of basement leakage. Please refer to the Roofing and Exterior sections of the report for more information.

Moisture penetration to basement storage room.

In the event that basement leakage problems are experienced, lot and roof drainage improvements should be undertaken as a first step. Please beware of contractors who recommend expensive solutions. Excavation, damp-proofing and/or the installation of drainage tiles should be a last resort. In some cases, however, it is necessary. Your plans for using the basement may also influence the approach taken to curing any dampness that is experienced.

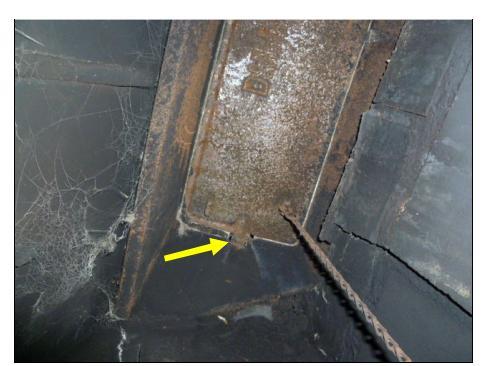
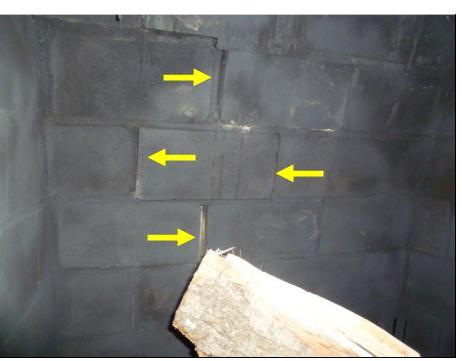
Damper does not open - missing control chain. Loose fire brick and missing mortar at rear wall.

- Repair: The fireplace damper requires repair does not open.
- **Repair:** The fireplace firebox mortar should be improved.
