Premier Home Inspection Report

Sample – Premier Home Inspection

Prepared By:
Structure & Site
Inspection Services LLC

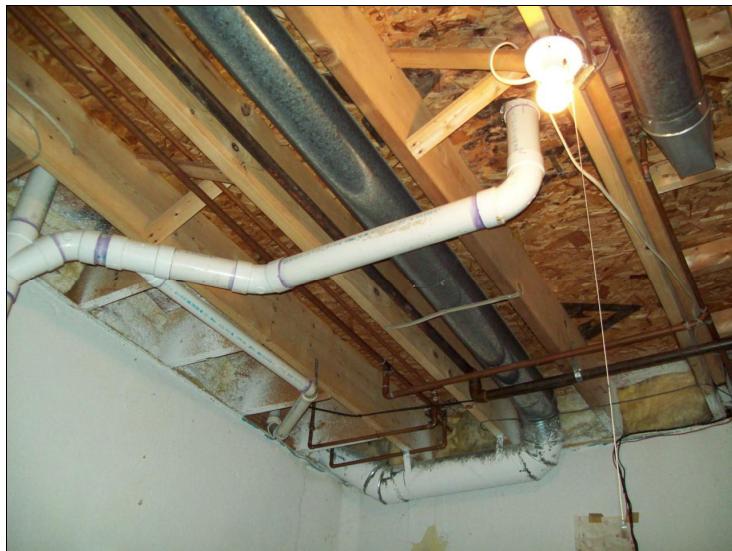
- **Monitor:** Settlement cracks were observed in the foundation walls. This implies that some structural movement of the building has occurred. Cracks of this type should be watched for any sign of additional movement. In the absence of any sign of ongoing movement, repair should not be necessary.
- **Monitor:** Finished basement concealed majority of floor framing and foundation materials.

View of structural materials and build methodology.

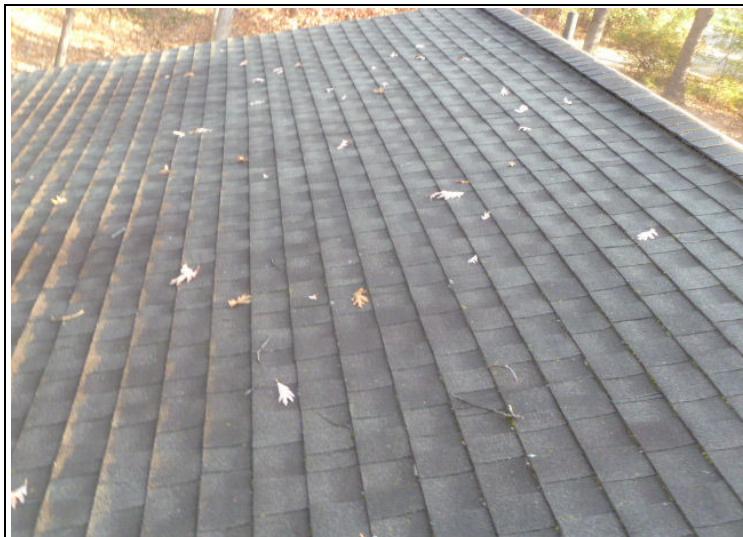
- **Monitor:** The roofing is in fair condition. We did not see evidence of active leaks or need for immediate major repair.
- **Improve:** Organic growth on roof surfaces should be treated to prevent decay of roof material. Recommend contacting www.roofmedic.com, a local company that applies an EPA registered chemical to the roof that removes the moss and other organic material for the surface material.

View of front slope of roof.

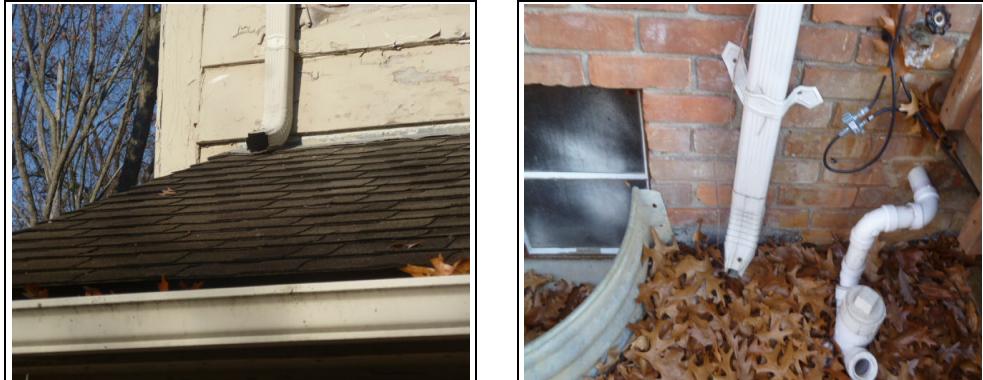
- **Repair:** The downspout(s) should discharge water at least five (5) feet from the house. Storm water should be encouraged to flow away from the building at the point of discharge.
- **Repair:** Downspout(s) that discharge onto the roof should be extended to discharge directly into the gutters below. This condition, if left unattended, can result in premature deterioration of the roofing under the end of the downspout.

Roof drainage configuration.

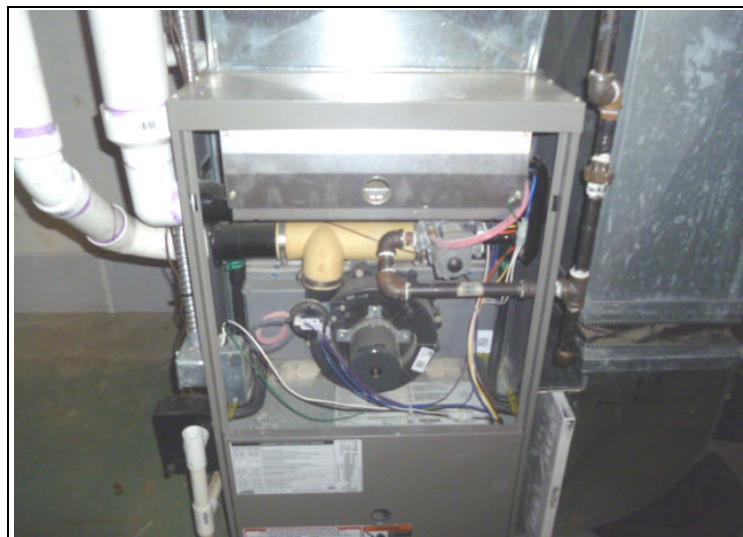
View of furnace unit.

- **Improve:** Duct cleaning is recommended.

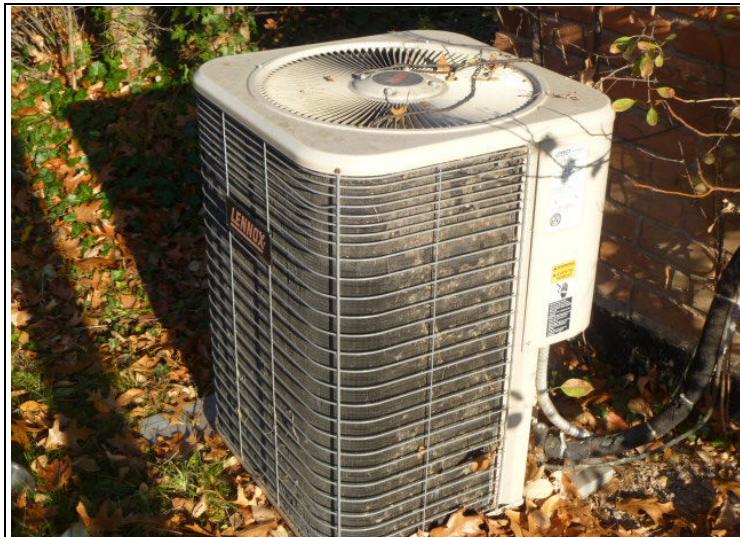
- **Improve:** The outdoor unit of the air conditioning system requires cleaning.
- **Improve:** Recommend covering the exterior A/C unit during the winter months. Also, turn breaker off at electrical panel to ensure that the unit is not accidentally turned on during the winter months, which can cause significant damage.
- **Repair:** The air conditioning system was not operated at the time of the inspection. Temperature below 60°.

Exterior A/C unit.

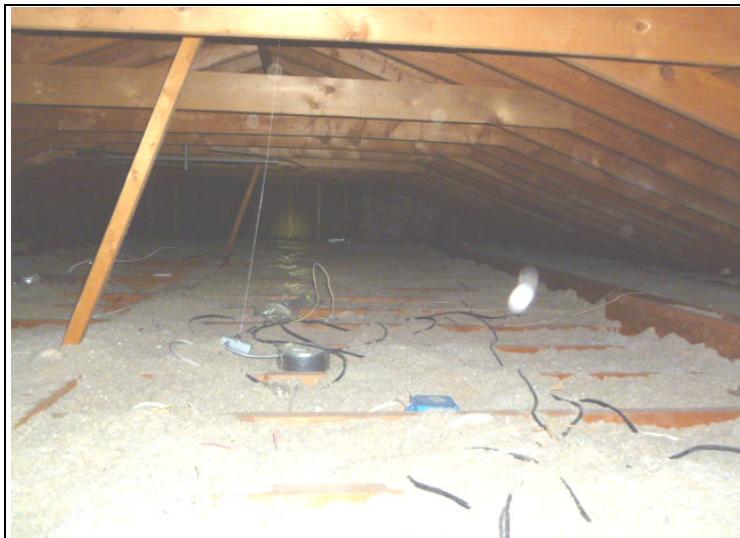
View of attic cavity, insulation levels and roof structure.
